Environmental Site Assessment Phase I

**Forsyth County Tax Block 0313
Lots 001,002A, 002B, 003, 102E, 102G**

**Prepared by
Geoscience and Technology, P.A.
For
Dolores Wiles
and
The City of Winston-Salem Department
of Enterprise Community Development**

July 2000

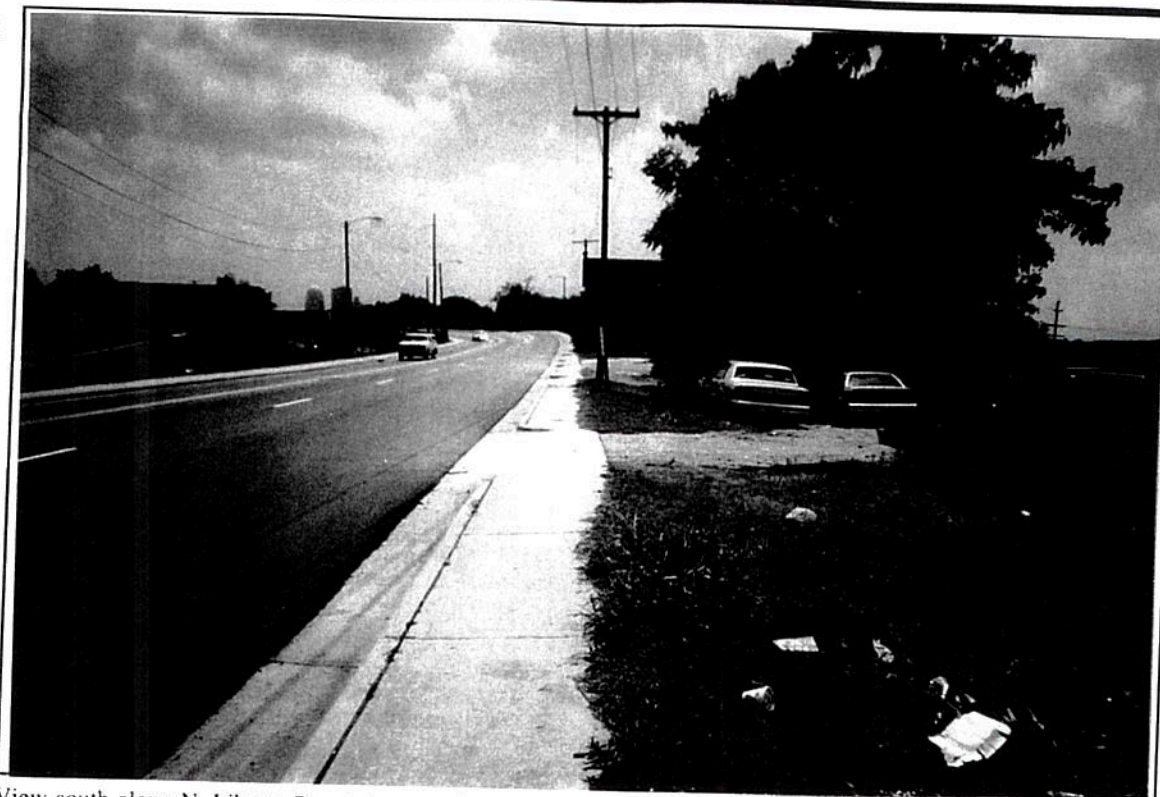
Figure 7a

View south along N. Liberty Street, from northeast corner of subject property, which lies on the right. Driveway at middle of photo leads into subject site.

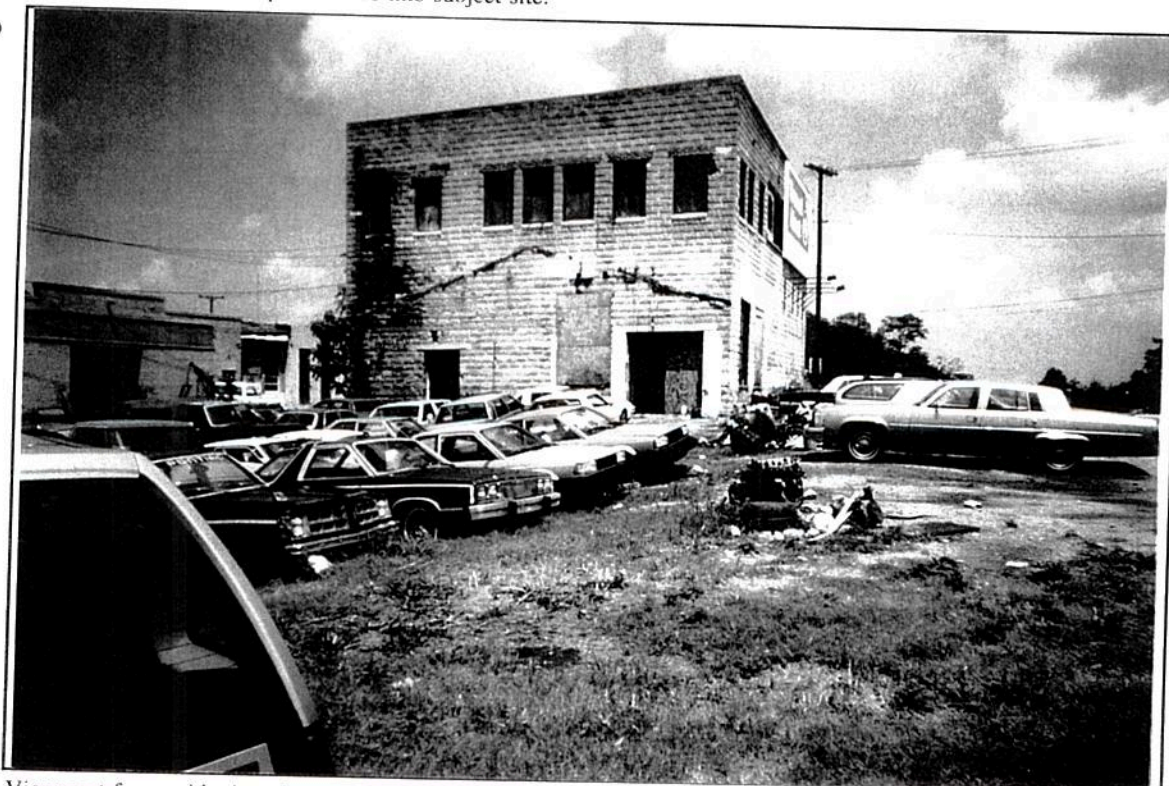
Figure 7b

drums (used as refuse containers) full of oil containers, packaging, and parts. A number of automobiles were visible on the subject site, some of which appeared not to be in working order. According to Mr. Wiles, parking on this part of the property is unauthorized but common. On the day of the inspection, one auto was apparently supported, on one corner, by a tank similar to a 20 pound propane tank. Dark staining and distressed vegetation were evident in this portion of the property, and odors of possible gasoline or mixed petroleum products were noticeable along portions of this property line.

View east from midpoint of north property line. Building at upper center is Tise Motors. Note cars and car parts, some of which are on the subject property. Soils in area between engine block and blue car at right appears stained.

On the date of the site walkover, onsite solid waste observed includes tires, an engine block, junked cars, paper, a gasoline tank, and oil containers. Most of these items were noted near the common boundary with adjacent Tise Motors (north), or in the northeastern quadrant of the subject site, where unauthorized vehicle parking occurs. These materials should be properly disposed.

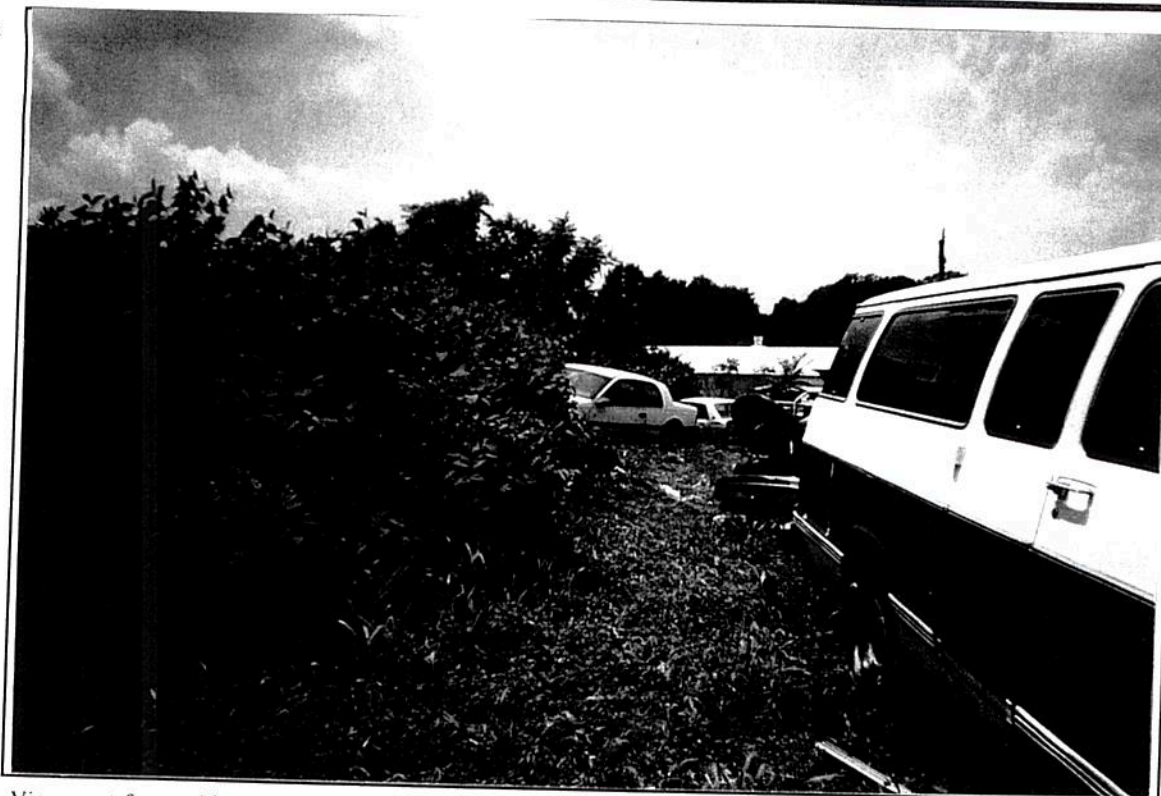
Figure 7c

View west from midpoint of north property line. Note old cars partially encroaching into undergrowth on subject property (left side of photo). Building in background is an R.J. Reynolds storage building.

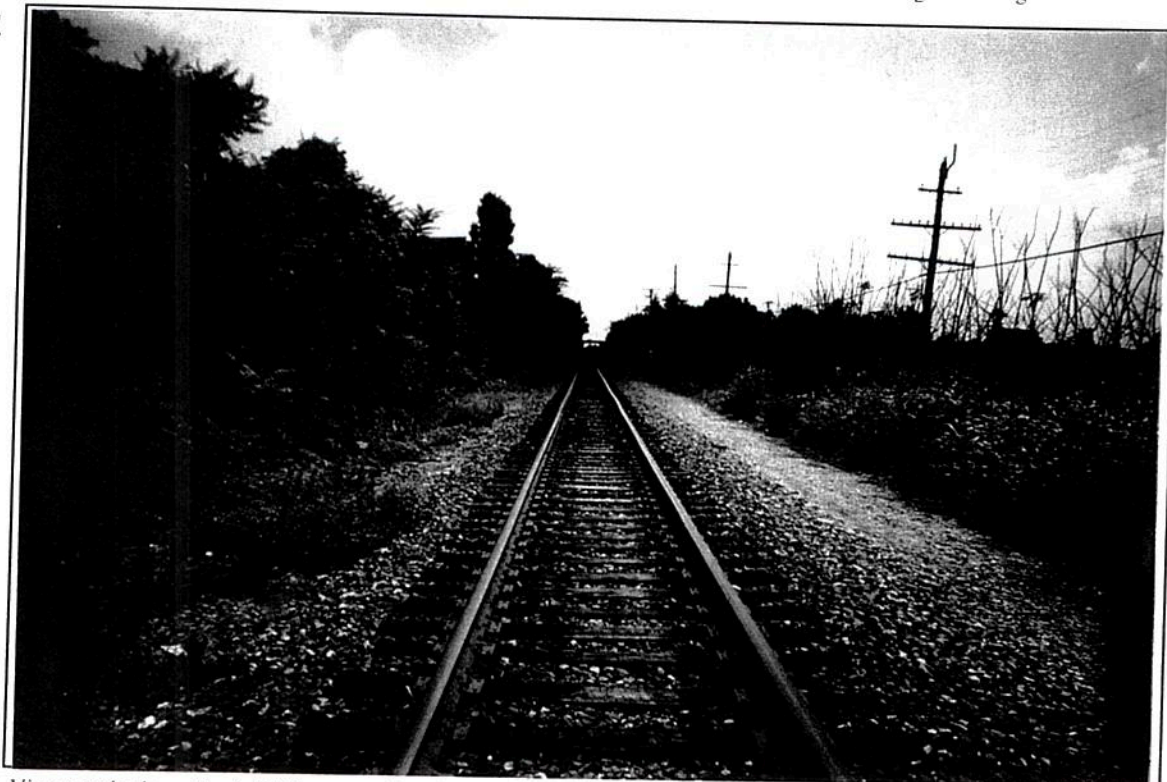
Figure 7d

View south along Norfolk-Western railroad. Subject property boundary lies at edge of gravelled area to left. Note storage buildings in far upper right.

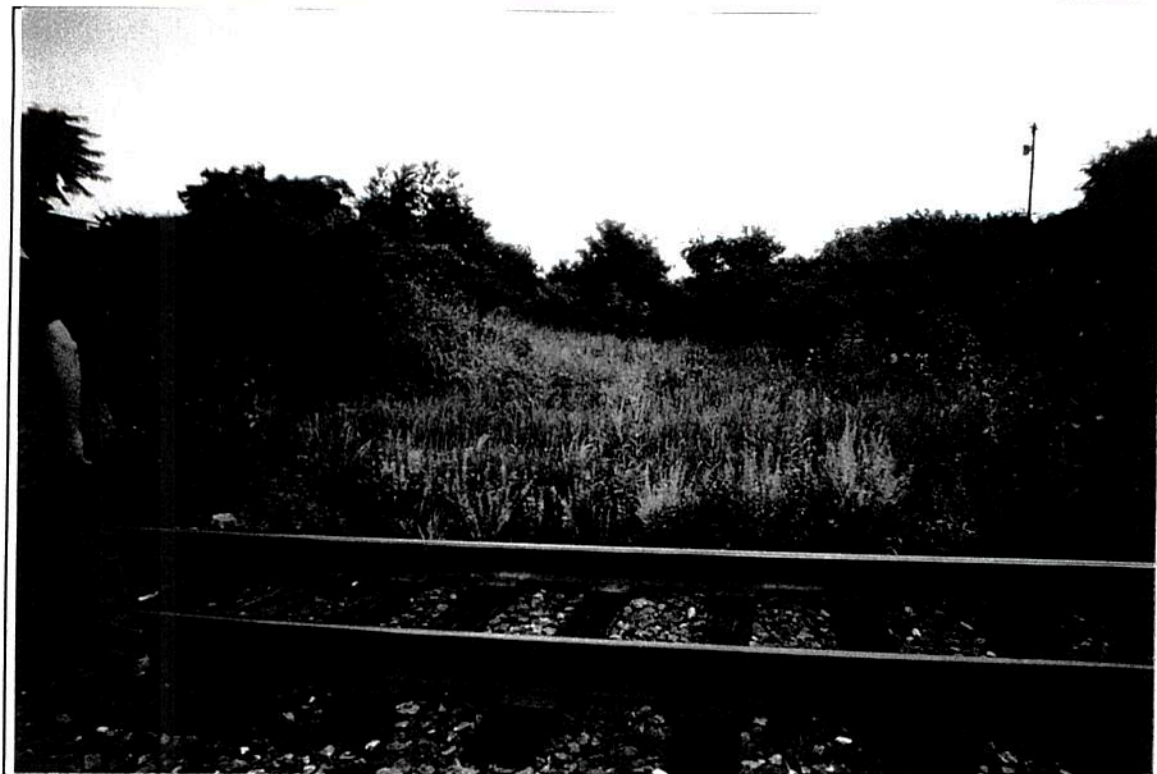
Figure 7e

Leaking electrical transformers are a primary source of polychlorinated biphenyl (PCB) contamination. Three transformers were noted near the subject site. One cylindrical transformer was observed on a power pole roughly at the southeast corner of the subject site, along N. Liberty Street. Two transformers, one of cylindrical design and the other a box transformer, are located on the north side of 23rd Street, approximately 75 to 100 feet north of the subject site. On the day of the inspection, the transformers appeared to be clean and well painted. No evidence of spillage was noted in underlying soils or on pavement.

View east from railroad toward low area on south end of subject site. The area near the trees (center) is the former location of Carpenter's Body Shop. South property line lies near right edge of photo. Note transformer, upper right.

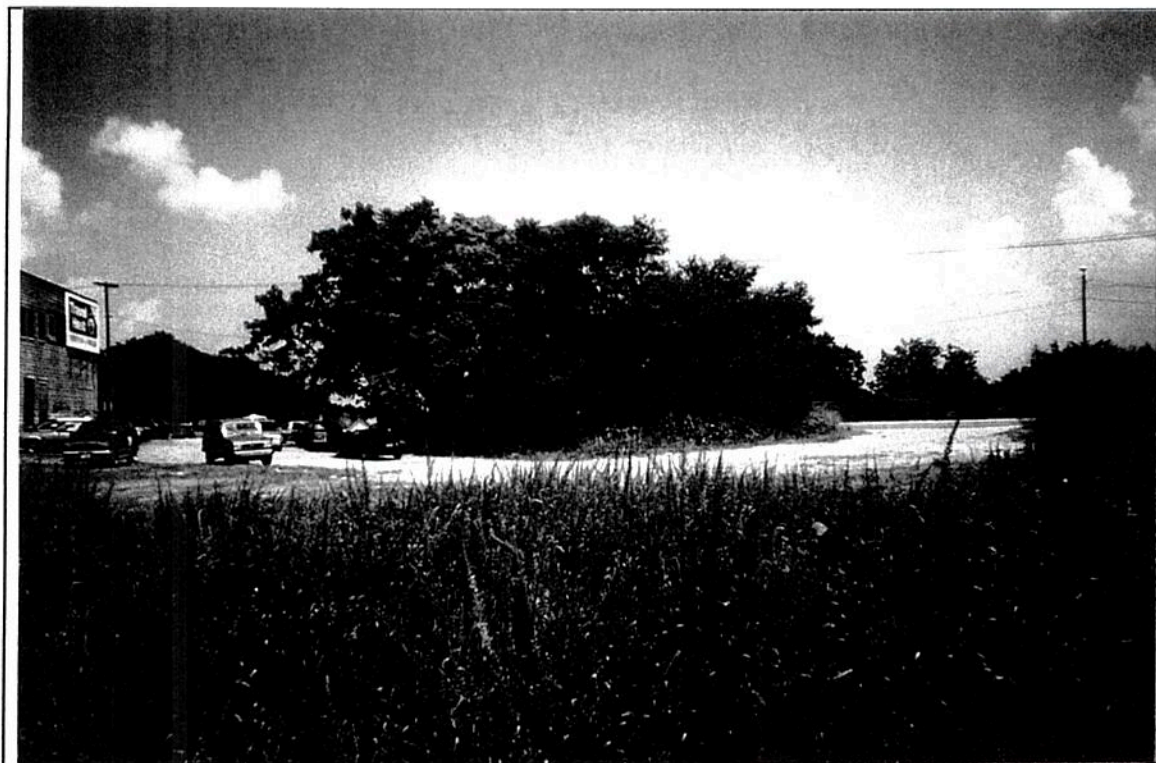
Figure 7f

View east from top of bank near west edge of subject site. Note circular drive-through with separate driveways onto N. Liberty Street. Note unauthorized parking of vehicles at left center. Tise Motors lies to far left.

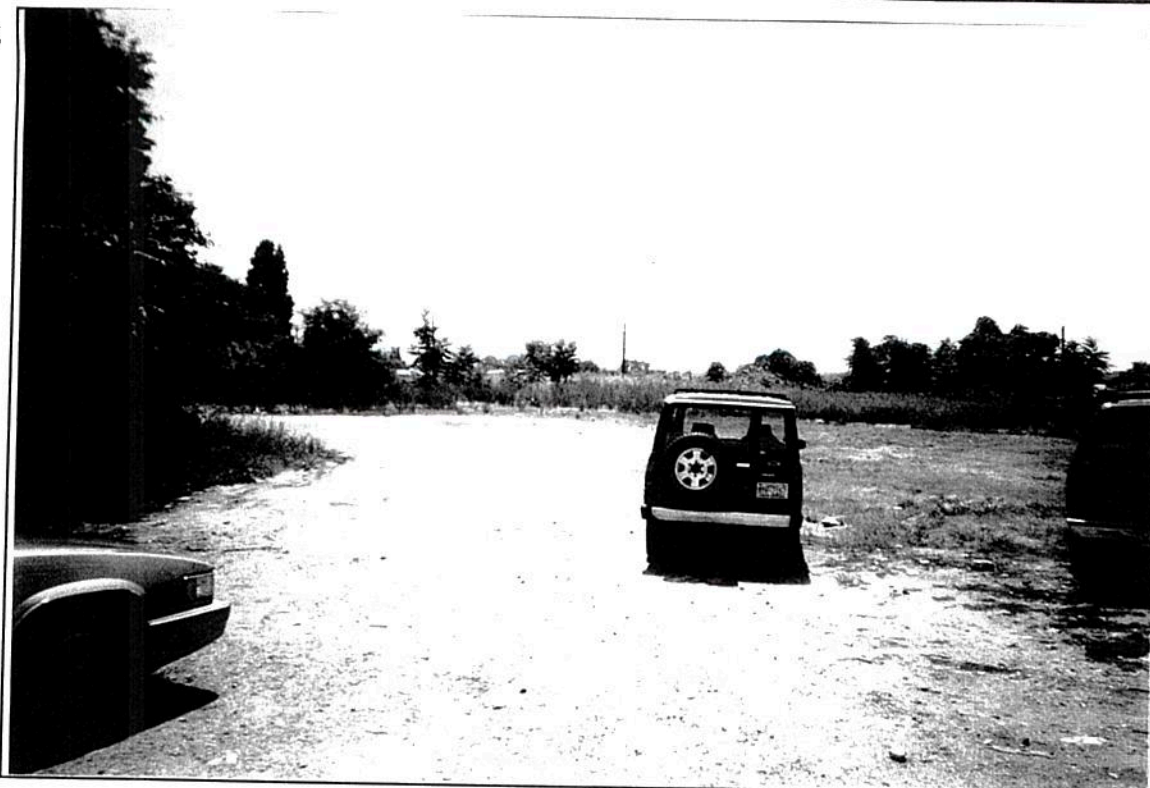
Figure 7g

View southwest from northeast quadrant, across drive-through area. Trees at far right center mark bank near western property boundary. Trees just left of center lie along bank above former Carpenter's Body Shop location.

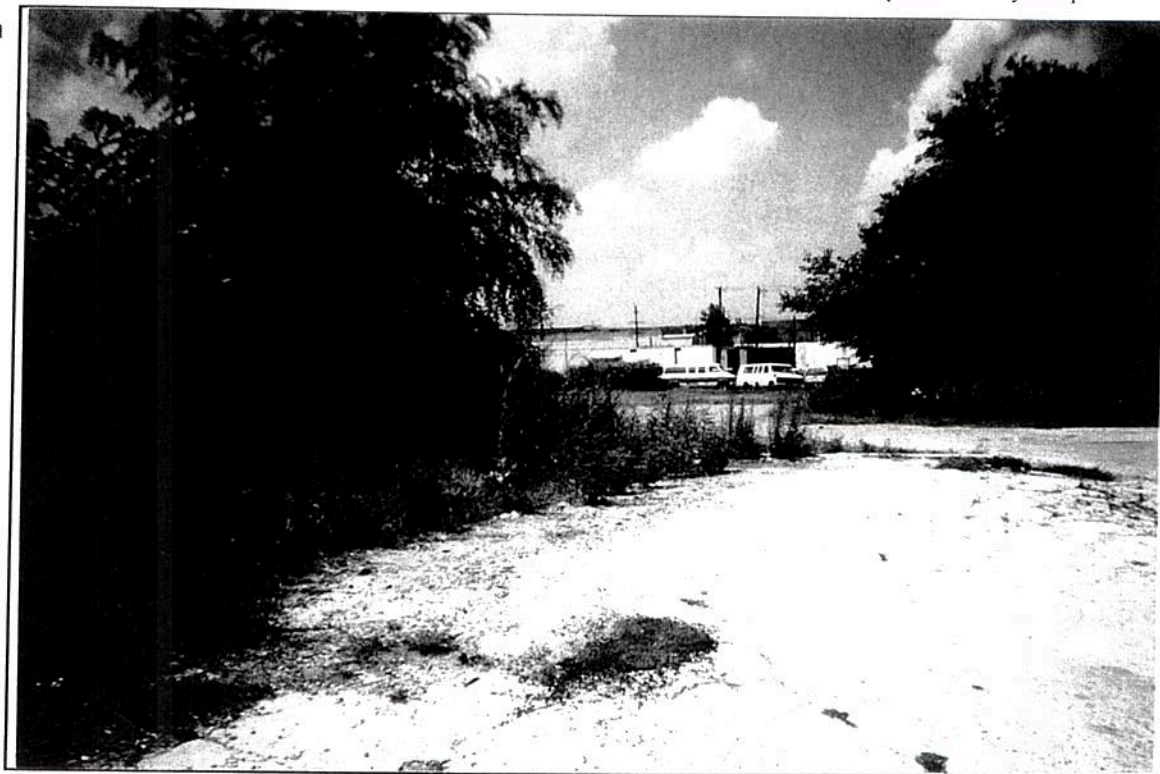
Figure 7h

View northwest from along N. Liberty Street near southeast corner of property. Cars in background are a part of Tise Motors operation. Slab in foreground may represent part of former Carpenter's Body Shop operation.

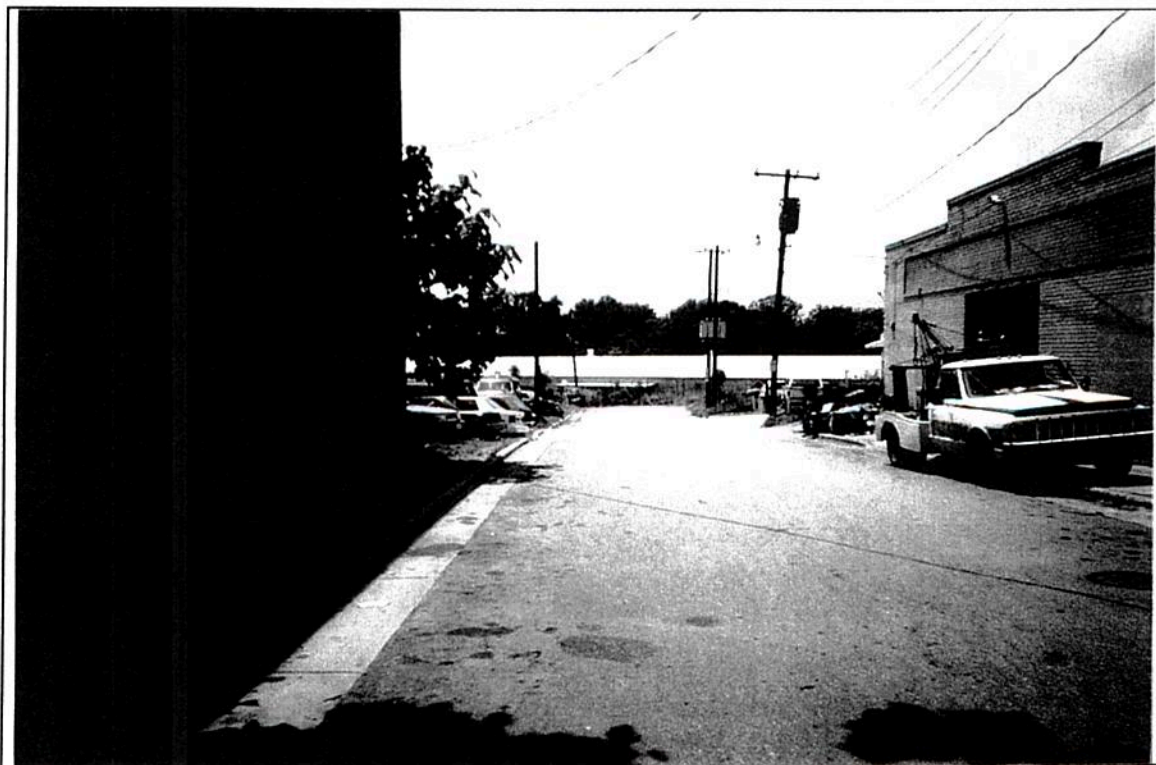
Figure 7j

View west along 23rd Street. Building to left is Tise Motors; building to right is another auto repair shop. R.J. Reynolds storage building lies in background. Note cylinder and box transformers along north side of 23rd Street.
